Manhole Inspection Summary

Manhole # S37U__034MH

Insp Date: **2/26/08 8:35 AM**

Location Address: **399 e fort**

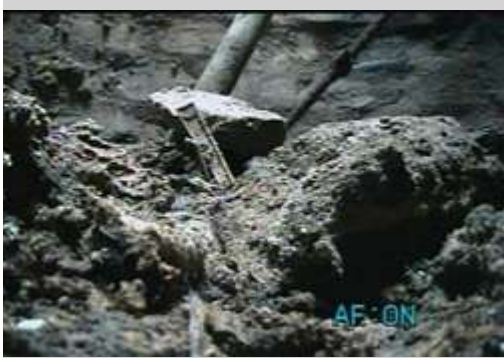
Defect 1

Condition: ☐ Sound ☐ Cracked ☐ Root Intrusion ☐ Deteriorated ☐ Leaks ☒ **Debris**

debris

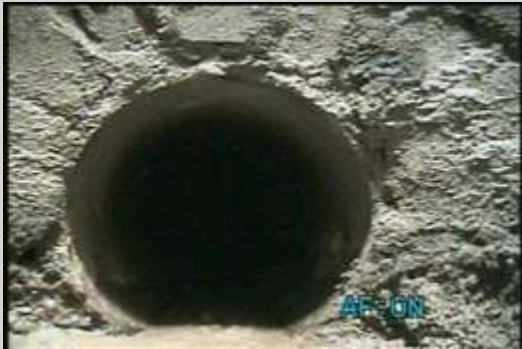
12 O'Clock Outflow

8 in. Circular Gravity Sewer
Pipe Out @ 12 O'Clock

Pipe Material: **Clay** ☐ Pipe Lined

Invert Depth: **9.40** (ft.) Flow Characteristics: **None**

Deposits: ☒ None ☐ Mud ☐ Sludge ☐ Debris ☐ Grease

Infiltration: **None** Pipe Seal Cond: **Unknown**
